NATIONAL PROGRAM FOR INSPECTION OF NON-FEDERAL DAMS  
NOYES BROOK DAM (ME 0..10) CORPS OF ENGINEERS WALTHAM  
MA NEW ENGLAND DIV SEP 81

REPORT DOCUMENTATION PAGE		READ INSTRUCTIONS BEFORE COMPLETING FORM
1. REPORT NUMBER  ME 00347	2. GOVT ACCESSION NO.	3. RECIPIENT'S CATALOG NUMBER
4. TITLE (and Subtitle)  Noyes Brook Dam  NATIONAL PROGRAM FOR INSPECTION OF NON-FEDERAL DAMS		5. TYPE OF REPORT & PERIOD COVERED  INSPECTION REPORT

20. ABSTRACT (Continue on reverse side if necessary and identify by block number)  >The earthfill embankment is 1000 ft. long and 31 ft. high. The facility was found in good condition. It is small in size with a high hazard classification. No urgent or emergency actions are required for the dam based on this inspection.

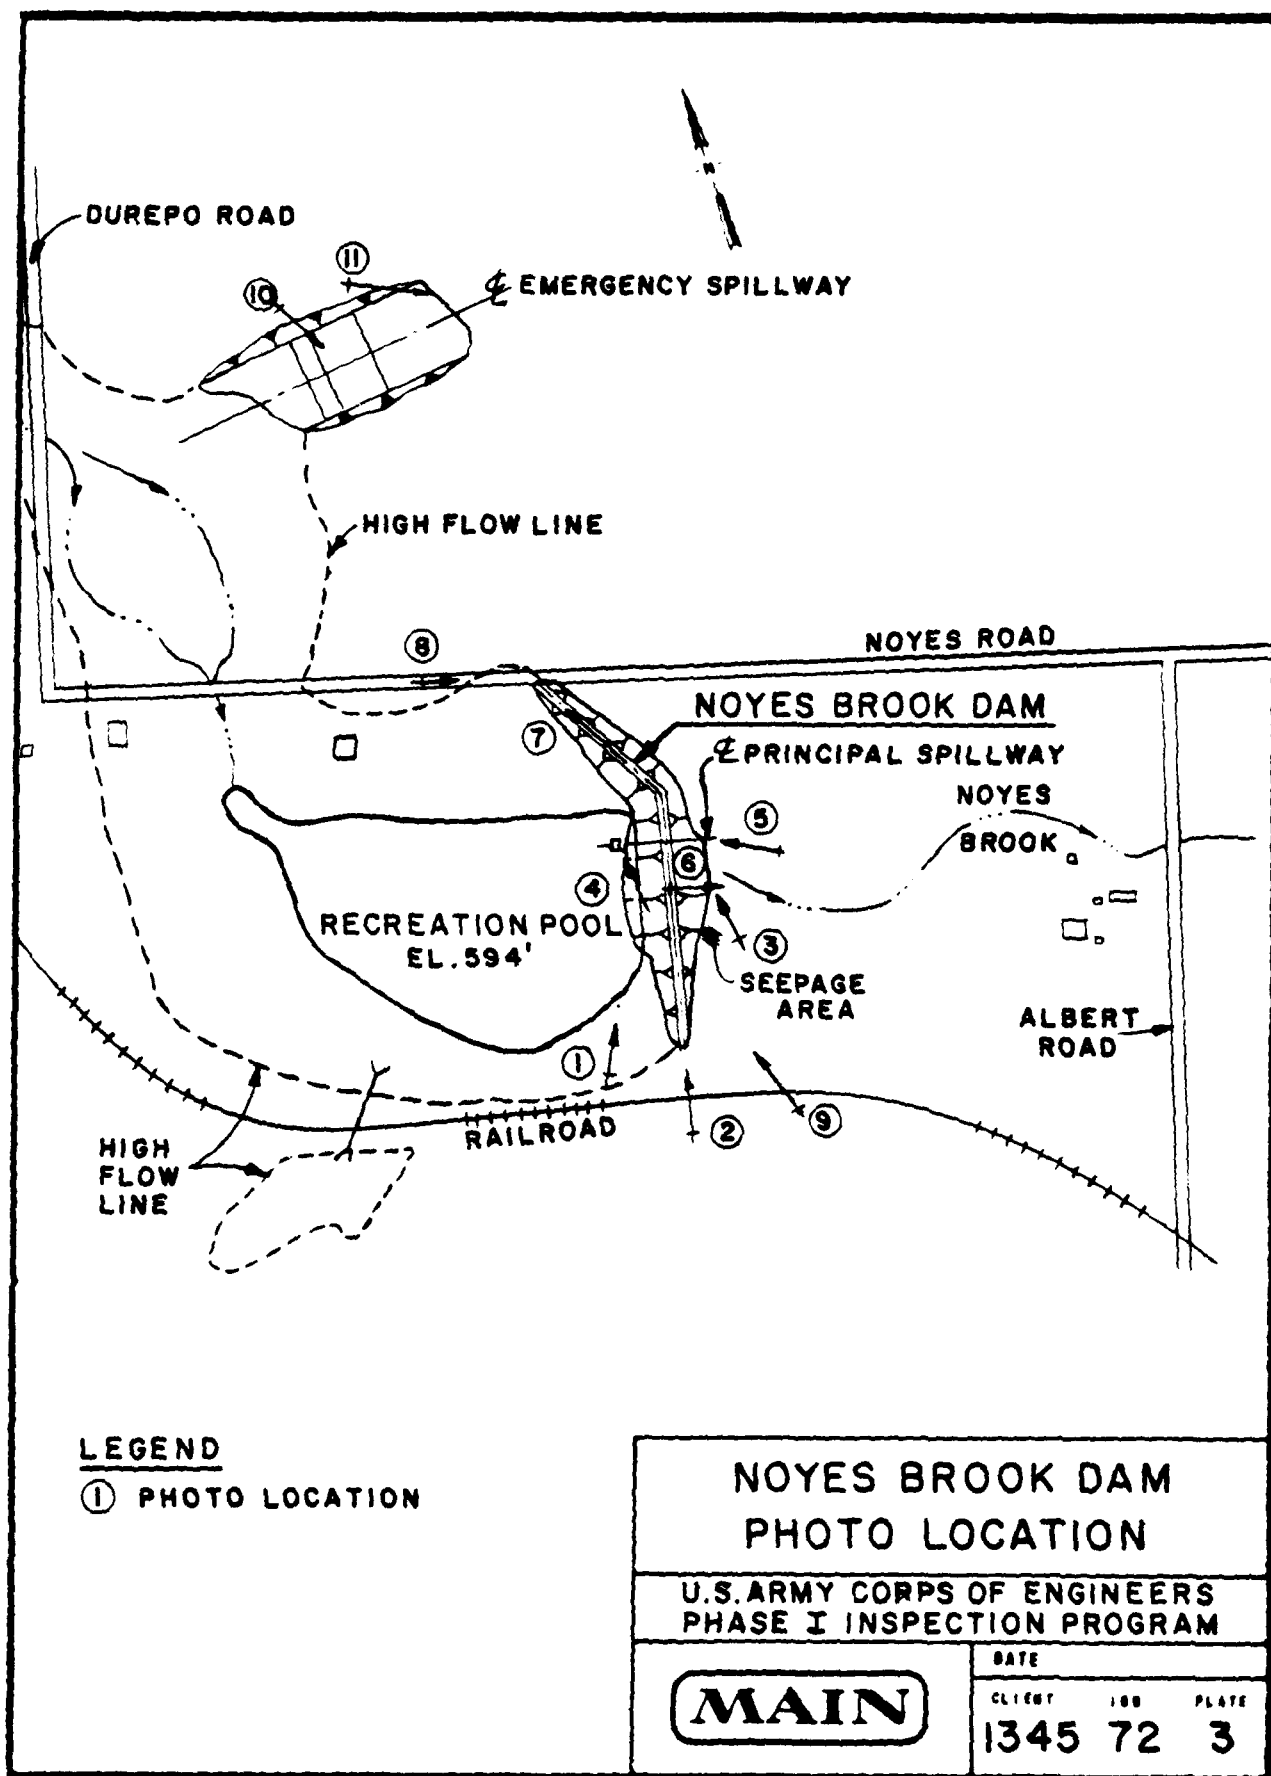
Photo 1  
Upstream Slope From  
Right Abutment

(2) Upstream slope - The upstream slope riprap appeared in good condition. The slope above the normal pool El. 594 has a well developed tight grass cover (Photo 1). There was no evidence of sloughing or erosion on the slope.
